COLORADO HISTORICAL SOCIETY Office of Archaeology and Historic Preservation 1300 Broadway Denver, CO 80203		SITE NO.: 5ME7814
HISTORIC BUILDING INVENTORY		Eligible for National Register <input type="checkbox"/> yes <input type="checkbox"/> no date _____ initials _____ Criteria <input type="checkbox"/> A <input type="checkbox"/> B <input type="checkbox"/> C <input type="checkbox"/> D Contributes to a potential National Register district <input type="checkbox"/> yes <input type="checkbox"/> no district name: _____
COUNTY: Mesa	CITY: Grand Junction	Eligible for State Register <input type="checkbox"/> yes <input type="checkbox"/> no date _____ initials _____ Criteria <input type="checkbox"/> a <input type="checkbox"/> b <input type="checkbox"/> c <input type="checkbox"/> d <input type="checkbox"/> e Areas of significance: _____
HISTORIC BUILDING NAME: Wilhemy, Walter, House		Period of significance _____ Needs data <input type="checkbox"/> date _____ initials _____

CURRENT BUILDING NAME:		LOCAL LANDMARK DESIGNATION: [<input type="checkbox"/>] yes [<input checked="" type="checkbox"/>] no Date of designation: N/A Designating authority: N/A
ADDRESS: 951 Main St., Grand Junction, CO 81501-

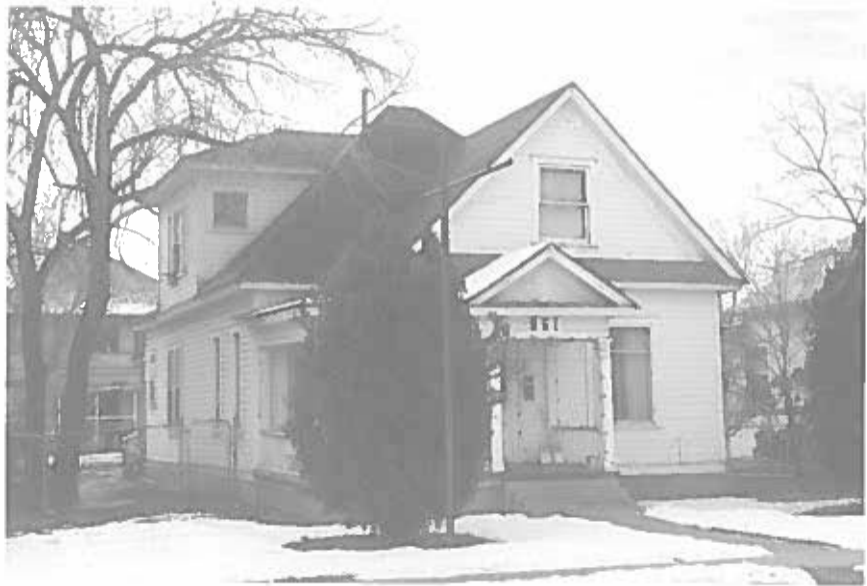
01/12/1996
Roll 15 Frame 20
View N Dir S/SW
SME7814

ARCHITECTURAL DESCRIPTION: One and a half story with cross gables. Concrete steps lead up to wrap around porch on east half of facade. Porch has hip roof with a pedimented gable with sunburst over the steps. Five full length squared columns around porch with ribbed wood balustrade. Front door is paneled with large light and white storm door. Windows are double hung wood sash, one-over-one. First floor facade window is transom style. Second story facade gable has a window with leaded glass in lozenge pattern in upper sash. Cutaway bay on west elevation. White simple drop siding and trim. Dark gray composition shingles on facade roof and brown on other slopes. Principal roof has a steep hip, with a pedimented gable on north slope and a large hip dormer on east slope with a similar dormer on the west slope. Small hip dormer and brick chimney on south slope.
A large arborvitae on east and west lawn. Two ash trees by east elevation. Chain link fence encloses back yard.
