<p>COLORADO HISTORICAL SOCIETY Office of Archaeology and Historic Preservation 1300 Broadway Denver, CO 80203</p> <p>HISTORIC BUILDING INVENTORY</p>		SITE NO.: 5ME8359
COUNTY: Mesa	CITY: Grand Junction	Eligible for National Register <input type="checkbox"/> yes <input type="checkbox"/> no date _____ initials _____ Criteria <input type="checkbox"/> A <input type="checkbox"/> B <input type="checkbox"/> C <input type="checkbox"/> D Contributes to a potential National Register district <input type="checkbox"/> yes <input type="checkbox"/> no district name: _____
HISTORIC BUILDING NAME: Palmer, Ralph R., House		Eligible for State Register <input type="checkbox"/> yes <input type="checkbox"/> no date _____ initials _____ Criteria <input type="checkbox"/> a <input type="checkbox"/> b <input type="checkbox"/> c <input type="checkbox"/> d <input type="checkbox"/> e Areas of significance: _____
CURRENT BUILDING NAME: Southall Residence		LOCAL LANDMARK DESIGNATION: [] yes [X] no Date of designation: N/A Designating authority: N/A

ADDRESS: 737 Hill Ave., Grand Junction, CO 81501-3229		P.M.: UTE township: 1S range:1W SE ¼ of SW ¼ of NW¼ of NE¼ of section 14
OWNER NAME & ADDRESS: Clarence A. So

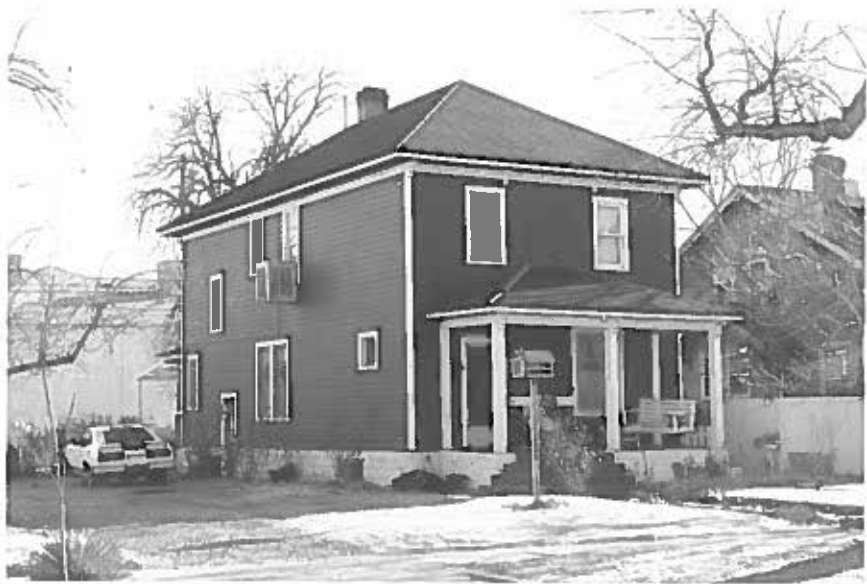
737 Hill Ave., Grand Junction, Mesa Co, CO
2945-141-23-004 03/21/1996
Roll 39 Frame 25 View N Dir SW

ARCHITECTURAL DESCRIPTION: Two story with hip roof. Concrete block foundation. Green concrete steps lead up to open porch with hip roof extending across the center seven eights of the facade. Three, full height, squared wood columns across the porch facade, and two responds. Wide simple drop siding on porch base. Screen door. The front door is paneled and has a large light. Windows are double hung wood sash, one-over-one; most windows have screens. A projecting bay with hip roof on the west elevation. Siding is deep green, simple drop wood. Foundation, porch base and columns, door and window surrounds, corner boards, frieze and cornices are white. The window screen frames, drip molding on the heads of the window surrounds, screen door, stripe on friezes and cornices are peach. Dark gray composition shingle roof with boxed eaves and cornices. The facade and porch cornices have scroll sawn white wood brackets. An enclosed porch with hip roof on the rear has an adjoining deck with a white fiberglass roof, and white 4x4 posts. A brick chimney is on the west slope.
