COLORADO HISTORICAL SOCIETY		SITE NO.: 5ME8434
Office of Archaeology and Historic Preservation 1300 Broadway Denver, CO 80203		Eligible for National Registeryesno
HISTORIC BUILDING INVENTORY		dateinitials
COUNTY: Mesa	Сту: Grand Junction	Eligible for State Registeryesno dateinitials Criteriaabcde Areas of significance:
HISTORIC BUILDING NAME: The house at 545 Teller Avenue		Period of significance
CURRENT BUILDING NAME: Brady Residence		LOCAL LANDMARK DESIGNATION: [ ] yes [X] no
		Date of designation; N/A Designating authority: N/A
ADDRESS: 545 Teller Ave., Grand Junction, CO 81501-2623		
		P.M.: UTE township: 1S range:1W SW 1/2 of SE 1/2 of NE1/2 of NW1/2 of section 14
OWNER NAME & ADDRESS: John E. Brady, Sr., 545 Teller Ave., Grand Junction, CO 81501-2623		UTM REFERENCE-12 Easting: 710800 Northing: 4327740
		USGS QUAD NAME: Grand Junction
		Year: 1962; photorevised 1973 [X] 7.5' [ ] 15'
STYLE: Vernacular Wood Frame		Block: 29 Lot(s): 12 Addition: Year of addition:

545 Teller Ave., Grand Junction, Mesa Co, CO 2945-142-17-008 03/11/1996 Roll 38 Frame 21 VIew N Dir S/SE

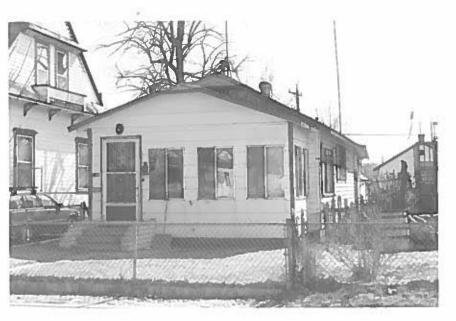
ARCHITECTURAL DESCRIPTION: One story with hip on gable roof. Concrete foundation is painted red. Concrete steps with brick piers lead to fully enclosed porch with hip on gable roof extending across nearly the entire facade. Porch entirely faced with aluminum clapboard siding. Porch glazing consists of seven windows, with pairs of metal frame sliding single lights. Metal storm door and a flush main door with three diagonally arranged lights on porch. Windows on the east elevation are double hung, wood sash, one-over-one. One of these windows has red, wood slat shutters. The west elevation has two large multi windows with metal frames and red, wood slat shutters. White simple drop slding. Brown composition roof shingles with overhanging eaves and exposed rafter ends.

Yard with sapling next to street. Front yard enclosed by chain-link fence. Side and backyards enclosed by low wire fence. Single car garage in rear with front gable, green composition roof shingles and white simple drop siding.
