COLORADO HISTORICAL SOCIETY Office of Archaeology and Historic Preservation		SITE NO.: 5ME8466	
1300 Broadway Denver, CO 80203 HISTORIC BUILDING INVENTORY		Eligible for National Registeryesno date initials CriteriaABCD Contributes to a potential National Register district yesno district name:	
County: Mesa	Сіту: Grand Junction	Eligible for State Registeryesno date initiats Criteriaabcde Areas of significance:	
I HISTORIC BUILDING NAME: Goodrich, Evin, House		Period of significance initials	
CURRENT BUILDING NAME: Carter Residence		LOCAL LANDMARK DESIGNATION: [] yes [X] no Date of designation: N/A Designating authority: N/A	
ADDRESS: 444 Hill Ave., Grand Junction, CO 81501-2528			
	0	P.M.: UTE township: 1S range:1W SW ½ of SW ½ of NE½ of NW½ of section 14	
OWNER NAME & ADDRESS: Terri R. Carter, 444 Hill Ave., Grand Junction, CO 81501-2528		UTM REFERENCE-12 Easting: 710660 Northing: 4327700	
		USGS QUAD NAME: Grand Junction

STYLE: Classic Cottage		Year: 1962; photorevised 1973 [X] 7.5' [] 15' Block: 30 Lot(s): 23 and E2 of 24 Addition: Year of addition:	
BUILDING TYPE;		[X] original location [] moved Date of moves(s):	
MATERIALS: Concrete Block Foundation - Wood Frame - Asphalt Shin

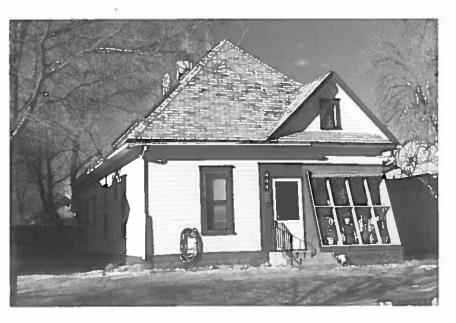
444 Hill Ave., Grand Junction, Mesa Co, CO 2945-142-16-012 02/28/1996 Roll 31 Frame 6 View S Dir N/NE 5ME 8466

ARCHITECTURAL DESCRIPTION: One story with hip roof. Concrete block foundation. Concrete steps and stoop have a wrought iron railing. The porch, integral in the east half of the facade, is now enclosed. Door is on west half of the enclosed porch and is paneled with a light. Two thirds of the porch front has greenhouse glazing with eight large fixed lights, four over four. A matchstick exterior shade rolls up and down over the greenhouse windows. Porch base is lattice-like... Windows around the house are double hung, wood sash, one over one. Lean-to wing across rear has single light casements. Buff simple drop, wood siding. Door and window surrounds, cornices, and the enclosing wall on the porch are dark olive. Foundation, water table and gable cornice are burgundy. Gray and red composition shingle roof. Boxed eaves have cornices. Cross gable on the east facade is pedimented with a kick. Gable face has fishscale wood shingles and a single light window. Both east and west slopes have two long, and one small, skylights. Brick chimney on ridge. Lawn with planting bed across facade. Spirea and roses on east lawn. Sycamore tree on parking area. High wood fence around the back yard. One car garage with front gable, green rolt composition roofing, buff simple drop siding and batten sliding door. Alley access. PHOTOGRAPHS (include photographs showing each side of building and any associated buildings) Film roll no.: 31 Photographer: Carolyn Howard Negative no.: 6 Location of negatives: City Of Grand Junction CONSTRUCTION HISTORY (include description and dates of major additions, alterations, or demolitions): Enclosed porch with greenhouse glazing and skylights. Roof materials to asphalt shingles, 1990. Additional construction or modifications not noted in Assessor's records. HISTORICAL BACKGROUND (discuss important persons and events associated with this building): Ada and William F. Muller, a painter with R. E. Starr, were the first owners/occupants, ca. 1907-1909. McCulloch and Goodale were the owners in 1915. Priscilla Goodale was the owner in 1917. Due to the fact that Grand Junction City Directories are not indexed prior to 1926, the next listed owners/occupants were Agnes and Erin M. Goodrich, manager of Juanita Milling and Fuel Company, ca. 1919-1941. Mrs. Anna Davis, widow of Gardner, was the occupant, ca. 1946. She is listed as a co-owner with Madge E. Davis, a teacher. INFORMATION SOURCES (be specific): Plat Map, Appraisal Card, Lot and Block Books, Grand Junction City Directories. SIGNIFICANCE (check appropriate categories) THEME(S): Architectural significance: Historical significance: [] represents the work of a master [] associated with significant person(s) [] possess high artistic value [] associated with significant event [X] represents a type, period, or method of [] associated with a pattern of events construction [] contributes to an historic district National Register eligibility: Individual [] yes [X] no Contributes to a potential district. Criteria: [] A [] B [] C [] D []yes [ X]no Area(s) of significance: Architecture **District name:** Period of significance: 1907 STATEMENT OF SIGNIFICANCE (briefly justify the significance checked above): The mass of the house is original. The greenhouse now used for a heat sump, and skylights reflect the energy consciousness of recent decades. Although not eligible for the National Register, this house may contribute to a local register. INVENTORY COMPLETED BY: Museum Group Staff DATE: 5/31/96 AFFILIATION: Museum of Western Colorado PHONE: (970) 241-9117 ADDRESS: PO Box 20000-5020, Grand Junction, Colorado 81502-5020 PROJECT NAME: Grand Junction Historic **Resources Survey, Phase 2**
