COLORADO HISTORICAL SOCIETY		SITE NO.: 5ME8531	
Office of Archaeology and Historic Preservation 1300 Broadway Denver, CO 80203		Eligible for National Registeryesno dateinitials CriteriaABCD Contributes to a potential National Register district	
HISTORIC BUILDING INVENTORY		yesno district name:	
COUNTY: Mesa	City: Grand Junction	Eligible for State Registeryesno date initials Criteriaabcde Areas of significance:	
HISTORIC BUILDING NAME: Williams, Orlo, House		Period of significance initials	
CURRENT BUILDING NAME:		LOCAL LANDMARK DESIGNATION: [] yes [X] no	
ADDRESS: 1319 Ouray Ave., Grand Junction, CO 81501		Date of designation: N/A Designating authority: N/A	
		P.M.: UTE township: 1S range:1W SE % of SW % of SW% of NW% of section 13	
OWNER NAME & ADDRESS: Marjory Donnelly, 13600 Braun Dr., Golden, CO 80401-2141		UTM REFERENCE-12 Easting: 711950 Northing: 4327320	
		USGS QUAD NAME: Grand Junction	
		Year: 1962; photorevised 1973 [X] 7.5' [] 15'

INVENTORY COMPLETED BY: Museum Group Staff	DATE: 5/31/96
AFFILIATION: Museum of Western Colorado	PHONE: (970) 241-9117
ADDRESS: PO Box 20000-5020, Grand Junction, Colorado 81502-5020	PROJECT NAME: Grand Junction Historic Resources Survey, Pha

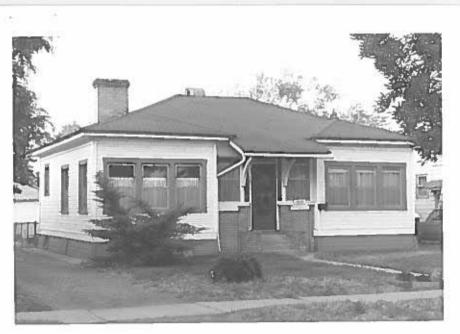
1319 Ouray Ave., Grand Junction, Mesa Co, CO 2945-132-21-003 05/14/1996 Roll 44 Frame 3 View N Dir SW 5m E853/

ARCHITECTURAL DESCRIPTION: One story with hip roof. Battered foundation skirted with blue false bevel siding. Two very shallow, hipped roof wings project slightly from the facade. Concrete steps with brick piers and concrete coping lead to front door in the center of facade. Door is flanked by narrow side lights and metal sash windows, one-over-one. Brick half-walls down to ground level. Entry slightly inset into the facade, is framed by the shallow, hipped roof wings and are covered by a shed roof, continuous with principal roof, and features curved knee braces. The shallow wings of the facade each have a ribbon of three metal sash windows, one-over-one, with metal frame screens. Windows around house are metal sash, one-over-one, with metal frame screens. White false bevel siding. Cornice, fascia, water table, and corner boards are white. Window surrounds are blue. Red composition shingle roof with boxed eaves. Brick chimney on east slope. Gable roof addition in rear with red composition roof shingles and white wide clapboard aluminum siding.
