COLORADO HISTORICAL SOCIETY Office of Archaeology and Historic Preservation 1300 Broadway Denver, CO 80203 HISTORIC BUILDING INVENTORY		SITE NO.: 5ME8584	
		Eligible for National Registeryesno date Initials CriteriaABCD Contributes to a potential National Register district	
		yesno district name:	
Соилту: Меза	CITY: Grand Junction	Eligible for State Register ves no date initials Criteria a b c d e Areas of significance:	
HISTORIC BUILDING NAME: G.J. Jehovah's Witness Church		Period of significance Needs data date initials	
CURRENT BUILDING NAME: Hightower Automotive		LOCAL LANDMARK DESIGNATION: [] yes [X] no	
ADDRESS: 415 Pitkin Ave., Grand Junction, CO 81501		Date of designation: N/A Designating authority: N/A	
		P.M.: UTE township: 1S range:1W NW ¼ of SW ¼ of SE¼ of SW¼ of section 14	
OWNER NAME & ADDRESS: Douglas K. Hein, 5420 Marshall St., Arvada, CO 80002-3862		UTM REFERENCE-12 Easting: 710635 Northing: 4326500

Architectural significance: [] represents the work of a master [] possess high artistic value [X] represents a type, period, or method of construction	Historical significance:] associated with significant person(s)] associated with significant event] associated with a

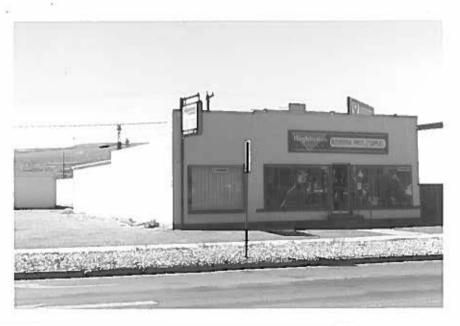
415 Pitkin Ave., Grand Junction, Mesa Co, CO 2945-143-39-002 04/29/1996 Roll 41 Frame 4 View N Dir SW • 5년 85 응식

ARCHITECTURAL DESCRIPTION: One story with flat roof, Concrete foundation. Concrete steps have pipe railings. The original building is the west three-quarters. It has a central metal frame door with a full light and push bars. Contiguous on both sides of the door are large show windows, two lights on each side with metal frames. The addition on the east has a large show window in a metal frame. The sills are concrete. An even parapet across the facade is six inches lower over the east addition. The facade has siding of foot wide vertical metal panels, with flanged overlapping joints. The metal is bright chrome yellow. Foundation, steps, rails, window frames and sills are red. East and west elevations have no windows. South elevation has one door. Siding on the west and south elevations is white pressed fiberboard in clapboard width. The addition has east and south elevations of white painted concrete block. Parapets on the elevations step down as they progress toward rear. Brick chimney on roof of a small flat roof rear wing.
