COLORADO HISTORICAL SOCIETY Office of Archaeology and Historic Preservation 1300 Broadway Denver, CO 80203		SITE NO.: 5ME7904
		Eligible for National Registeryesno
		date initials CriteriaABCD
HISTORIC BUILDING INVENTORY		Contributes to a potential National Register district
		yesno district name:
		Eligible for State Registeryesno
COUNTY: Mesa	Citry: Grand Junction	date initials Criteriaabcde
		Criteriaabcde Areas of significance:
HISTORIC BUILDING NAME: Hall, Frank, House		
		Period of significance initials
CURRENT BUILDING NAME: Mickelsen Residence		LOCAL LANDMARK DESIGNATION: [] yes [X] no
		Date of designation: N/A
ADDRESS: 850 Hill Ave., Grand Junction, C	O 81501-3232	Designating authority: N/A
		P.M.: UTE township: 1S range:1W SE ½ of SE ½ of NW½ of NE½ of section 14
OWNER NAME & ADDRESS: Kalvin C. Mickelsen, 850 Hill Ave., Grand Junction, CO 81501-3232		UTM REFERENCE-12 Easting: 711300
		Northing: 4327720

INVENTORY COMPLETED BY: Museum Group Staff		DATE: 3/29/96		
AFFILIATION: Museum of Western Colorado		PHONE: (970) 241-9117		
ADDRESS: PO Box 20000-5020, Grand Junction, Colorado 81502-5020		PROJECT NAME: Grand Junction Historic Resources Survey, Phase 2

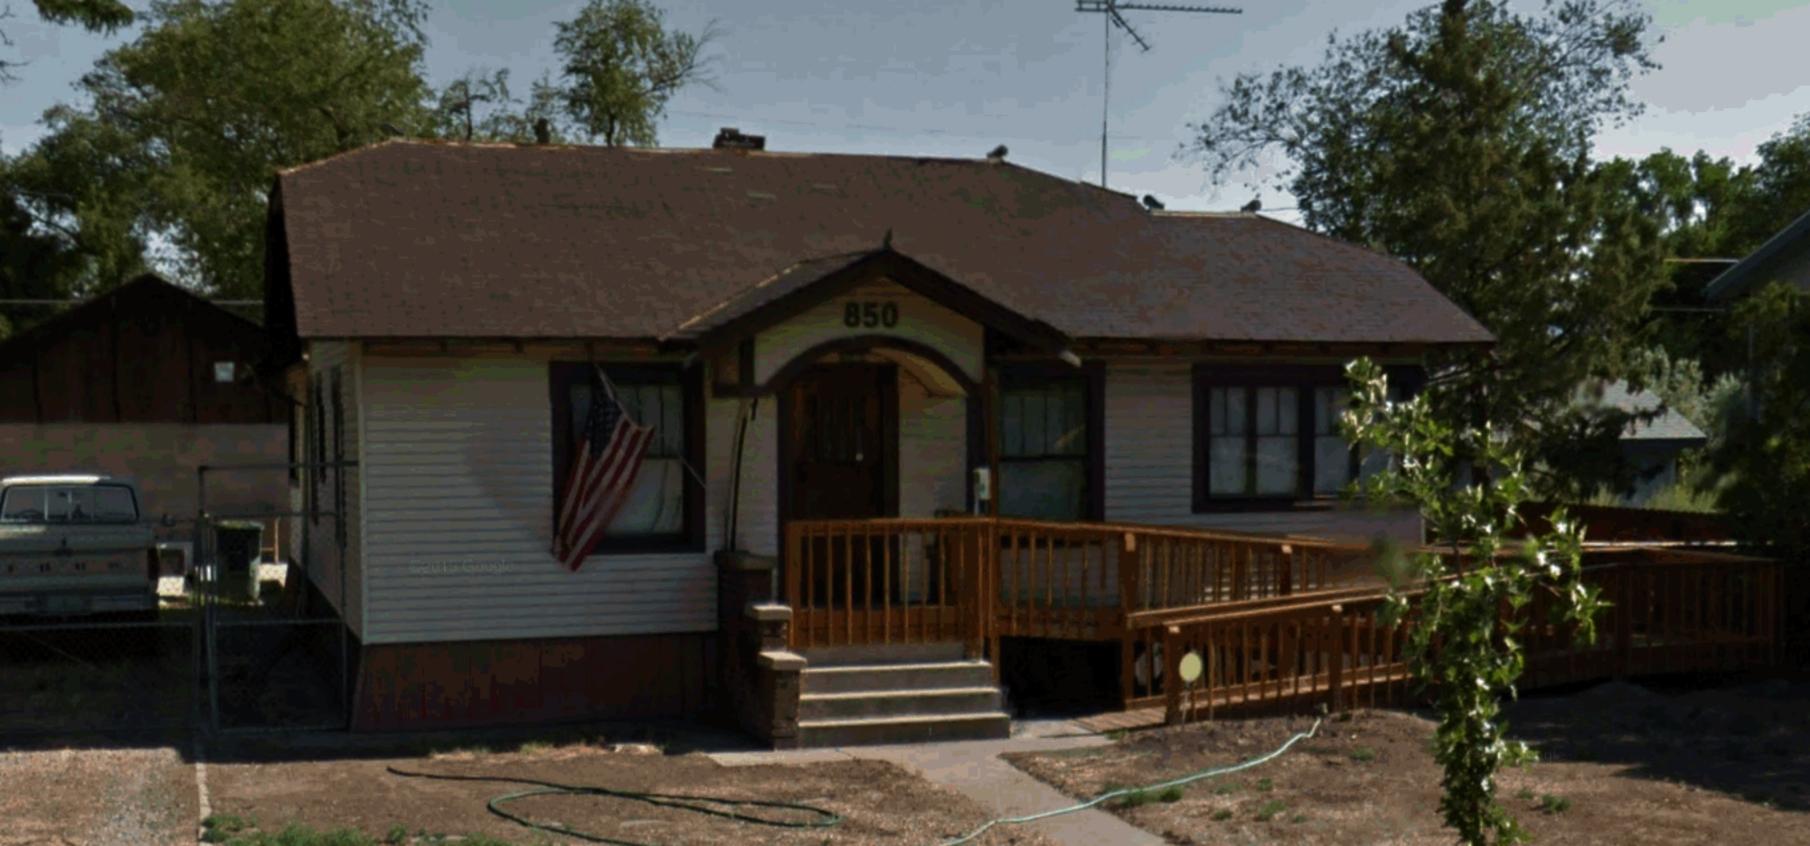
850 Hill Ave., Grand Junction, Mesa Co, CO 2945-141-15-015 1/29/1996 Roll 19 Frame 18 View S Dir N/NE 5ME7904

ARCHITECTURAL DESCRIPTION: One story with side hip on gable. Battered foundation. Concrete steps and stoop with brick plers. Concrete coping on piers. Gabled portico over stoop has curved celling and is supported by two long, curved wall braces. Siding on portico gable face. Front door is paneled and has four vertical lights. Windows are double hung wood sash, five and four vertical lights over one. Sunroom is a short wing on the east elevation with a hip on gable roof. Fenestration on three sides is ribbons of casements, one-over-one. Storm windows on all windows around house. Yellow narrow lapped siding. Window and door surrounds, foundation, comer boards, side gables with board and batten siding, bargeboards and rafter ends are brown. Brown composition shingle roof. Exposed rafter ends. Shaped bargeboard tails. Curved metal finials on ridges. Brick chimney on east slope. Two large arborvitae bushes obscure the east facade and a large cedar on the west facade. Row of arborvitae on east lawn. Lattice fence on east lawn, chain link fence on west lawn. Elm tree in parking area. Two car garage at rear with flat roof, stepped parapets, yellow false bevel siding, and folding paneled door. Also, large two car garage with alley access is a later addition. Front gable, gray composition shingle roof, concrete block construction and contemporary metal door.
