<p>COLORADO HISTORICAL SOCIETY Office of Archaeology and Historic Preservation 1300 Broadway Denver, CO 80203</p> <p>HISTORIC BUILDING INVENTORY</p>		SITE NO.: 5ME7830 Eligible for National Register <input type="checkbox"/> yes <input type="checkbox"/> no date _____ initials _____ Criteria <input type="checkbox"/> A <input type="checkbox"/> B <input type="checkbox"/> C <input type="checkbox"/> D Contributes to a potential National Register district <input type="checkbox"/> yes <input type="checkbox"/> no district name: _____ Eligible for State Register <input type="checkbox"/> yes <input type="checkbox"/> no date _____ initials _____ Criteria <input type="checkbox"/> a <input type="checkbox"/> b <input type="checkbox"/> c <input type="checkbox"/> d <input type="checkbox"/> e Areas of significance: _____ Period of significance _____ Needs data <input type="checkbox"/> date _____ initials _____

COUNTY: Mesa	CITY: Grand Junction	LOCAL LANDMARK DESIGNATION: <input type="checkbox"/> yes <input checked="" type="checkbox"/> no Date of designation: N/A Designating authority: N/A P.M.: UTE township: 1S range:1W NW ¼ of NE ¼ of SE¼ of NE¼ of section 14
HISTORIC BUILDING NAME: Schmidt, Marqu

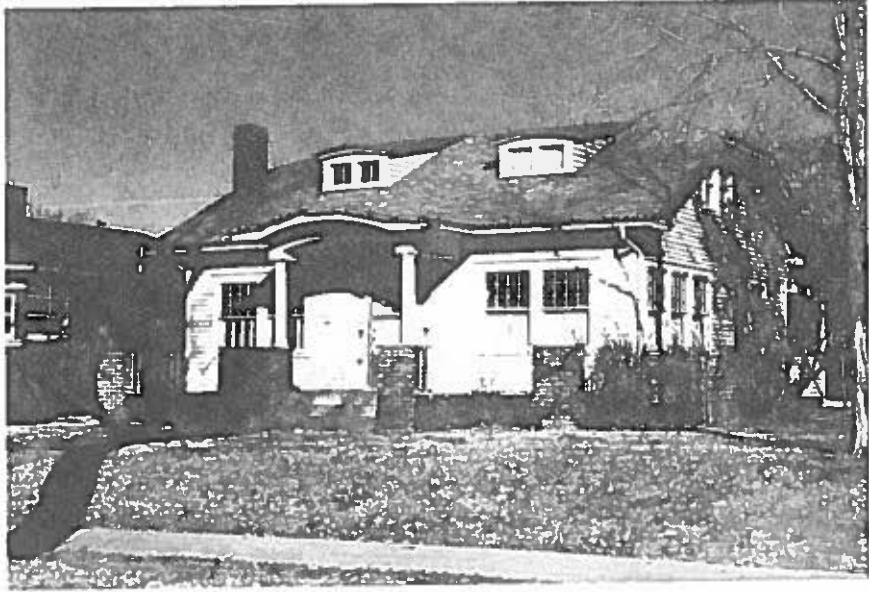
1030 Gunnison Ave.
Grand Junction, Mesa Co, CO
2945-141-20-011
5ME7830

ARCHITECTURAL DESCRIPTION: One and a half story with side hip on gable roof. Broad concrete steps lead up to terrace extending across facade. Four wire cut brick piers extend across terrace facade. White metal railings and braces are between the piers. Two piers, which flank the steps, support Tuscan half-columns. These columns support a portico with a segmental arched ceiling and roof. On the west end of the terrace is another set of steps which descend toward the side driveway. Paneled front door is flanked by full length sidelights of leaded, and some stained, glass. Windows are double hung wood sash, twelve over one, and pairs of twelve light casements on west elevation. Symmetrical facade has paired windows on each side. Small paired sliding windows in dormers. Pink clapboard siding. White window and door surrounds, columns, friezes, cornices and raking cornices. Brown composition shingle roof. Two small dormers on south slope with segmental arched roofs. Boxed eaves with cornices. Gables have return cornices. Full height fireplace chimney of wire cut brick on west gable wall. Another brick chimney on north slope.

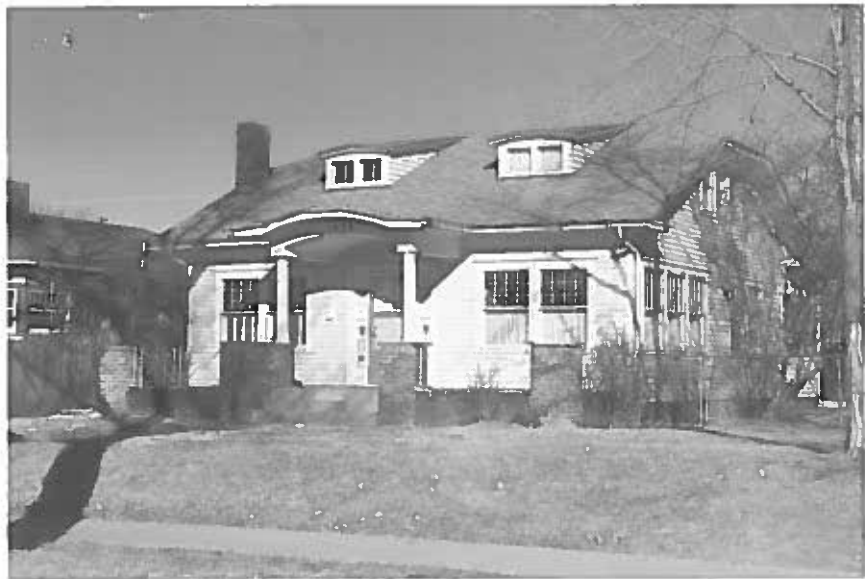
1030 Gunnison Ave.
Grand Junction, Mesa Co, CO
2945-141-20-011
5ME7830

01/12/1996
Roll 18 Frame 12
View S Dir NW
5ME7830
