COLORADO HISTORICAL SOCIETY Office of Archaeology and Historic Preservation 1300 Broadway Denver, CO 80203		SITE NO.: 5ME7851
HISTORIC BUILDING INVENTORY		Eligible for National Register <input type="checkbox"/> yes <input type="checkbox"/> no date _____ initials _____ Criteria <input type="checkbox"/> A <input type="checkbox"/> B <input type="checkbox"/> C <input type="checkbox"/> D Contributes to a potential National Register district <input type="checkbox"/> yes <input type="checkbox"/> no district name: _____
COUNTY: Mesa	CITY: Grand Junction	Eligible for State Register <input type="checkbox"/> yes <input type="checkbox"/> no date _____ initials _____ Criteria <input type="checkbox"/> a <input type="checkbox"/> b <input type="checkbox"/> c <input type="checkbox"/> d <input type="checkbox"/> e Areas of significance: _____
HISTORIC BUILDING NAME: Kendall, Richard, House		Period of significance _____ Needs data <input type="checkbox"/> date _____ initials _____

CURRENT BUILDING NAME: Freeman Residence		LOCAL LANDMARK DESIGNATION: <input type="checkbox"/> yes <input checked="" type="checkbox"/> no Date of designation: N/A Designating authority: N/A
ADDRESS: 1057 Ouray Ave., Grand J

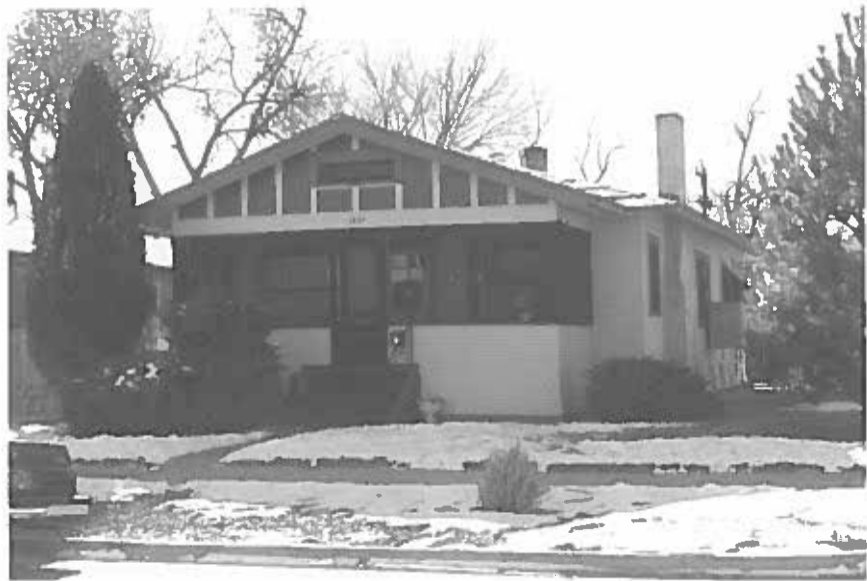
01/12/1996
Roll 18 Frame 20
View N Dir S/SE
SME7851

ARCHITECTURAL DESCRIPTION: One story with hip roof. Battered foundation. Painted concrete steps with green carpeting and wrought iron railing lead up to gabled screened porch extending across seven-eighths of facade. Porch half-walls have siding nearly to ground level. Black, squared half-columns are placed on front corners of the porch. Black screen door. Paneled front door with four lights. Windows are double hung, wood sash, one-over-one, with black framed window screens. Gray false bevel siding. Window and door surrounds, bargeboards are darker gray. Narrow strip of concrete foundation which shows under battered foundation is red. Red composition shingle roof with exposed rafter ends. Bargeboards have notched ends. Gable face over porch is red stucco, with gray ornamental half-timbering and a wide, narrow window. Brick chimney on ridge. Pale buff brick, full height fireplace chimney on west eave wall.

STATEMENT OF SIGNIFICANCE (briefly justify the significance checked above): A fine example of a Bungalow. The porch screens and their frames, the screen door, and porch columns are all black, blending together to make a strong horizontal emphasis on the facade. Although not eligible for the National Register, this house may contribute to a local register.
