COLORADO HISTORICAL SOCIETY Office of Archaeology and Historic Preservation		SITE NO.: 5ME7860
	Denver, CO 80203	Eligible for National Registeryesno
HISTORIC BUILDING INVENTORY		dateinitials CriteriaABCD Contributes to a potential National Register districtyesno district name:
County: Mesa	Crry: Grand Junction	Eligible for State Register
HISTORIC BUILDING NAME: Lewis, Willard, House		Period of algnificance
CURRENT BUILDING NAME: Ring Residence		LOCAL LANDMARK DESIGNATION: [] yes [X] no
ADDRESS: 1001 Gunnison Ave., Grand Junction, CO 81501-3225		Date of designation: N/A Designating authority: N/A
		P.M.: UTE township: 1S range:1W SE 1/4 of NW 1/4 of NW1/4 of NE1/4 of section 14
OWNER NAME & ADDRESS: Joanne Ring, 1001 Gunnison Ave., Grand Junction, CO 81501-3225		UTM REFERENCE-12 Easting: 711480 Northing: 4327560
		USGS QUAD NAME: Grand Junction
		Year: 1962; photorevised 1973 [X] 7.5' [] 15'
STYLE: Bungalow		Block: 46 Lot(s): 1 and 2 Addition: Year of addition:

INVENTORY COMPLETED BY: Museum Group Staff	DATE: 3/29/96
AFFILIATION: Museum of Western Colorado	PHONE: (970) 241-9117
ADDRESS: PO Box 20000-5020, Grand Junction, Colorado 81502-5020	PROJECT NAME: Grand Junction Historic Res

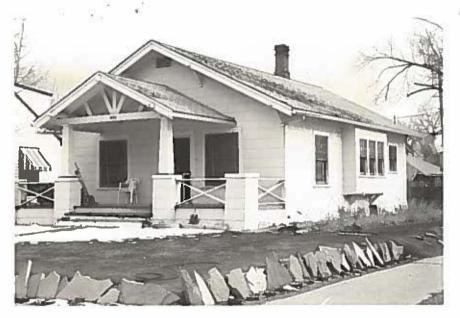
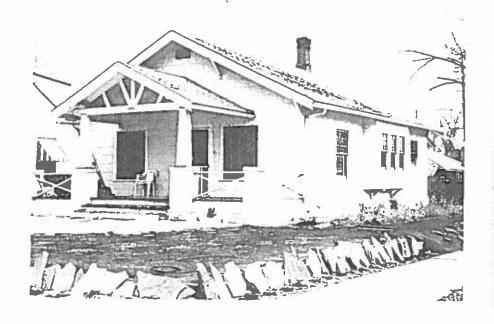
1001 Gunnison Ave., Grand Junction, Mesa Co, CO 2945-141-29-001 1/29/1996 Roll 20 Frame 02 View N Dir SW 5ME7860

ARCHITECTURAL DESCRIPTION: One story with a front gable. Broad wood steps lead to open terrace extending across facade. The center third of the terrace has a gabled porch roof. There is a shingled pier at both front corners of the terrace, and two piers flank the steps. The pair of piers by the steps each support a shingled column. A tie beam rests on the columns. The roof above is supported by a king post and four angled posts which rest on the tie beam. Railings on porch between piers with wood braces forming an "X". Front door is paneled with four vertical, beveled lights. Windows are double hung wood sash, twelve, eighteen, and twenty-one over one. A projecting bay window on the west elevation bay is under the eave of the roof, and is supported by knee braces. Pink asbestos shingle siding. Steps, coping of porch, piers, columns, and porch gable timbers, door and window surrounds, bargeboards, and knee braces are white. Window frames and muntins are green. Light gray composition shingle roof with bargeboards. Knee braces under eaves of principal roof. Brick chimney on ridge.

Two car garage at rear with hip roof, gray composition shingles, white simple drop siding, and two sliding batten doors.
