PROJECT NAME: Grand Junction Historic Resources Survey, Phase 2

1020 Chipeta Ave. , Grand Junction, Mesa Co, CO

5ME7866

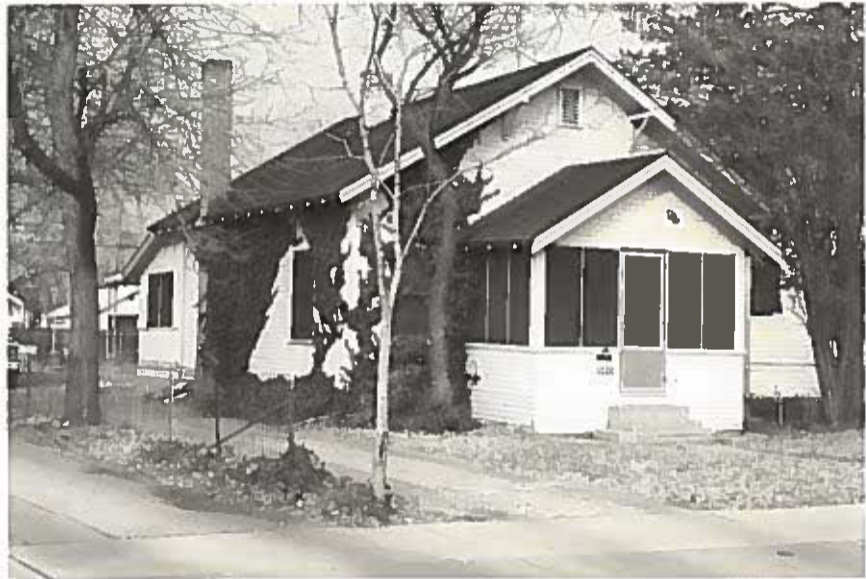
Roll 20 Frame 04 View S Dir NE

ARCHITECTURAL DESCRIPTION: One story with front gable. Concrete steps lead up to gabled screen porch on center of facade. Siding on porch half-wall goes down to ground level. A squared 6 x 6 half-column on front corners of porch. Screen door. Front door is paneled, with eight lights. Windows are double hung wood sash, one-over-one. White narrow lapped siding. Trim is white, except for brown window screen frames. Red cedar shingle roof with exposed rafter ends and bargeboards. Knee braces under eaves. Full height brick fireplace chimney on west eave wall. A brick chimney also on west slope.

One car garage at rear with front hip on gable, cedar shingle roof, white narrow lapped siding, and folding garage doors with three sections, four lights in each section.
